# Manhole Inspection Summary

Manhole # S25MM1016MH

Insp Date: **12/18/06 9:53 AM**

**Location** Address: **4500 ROLAND AVE**

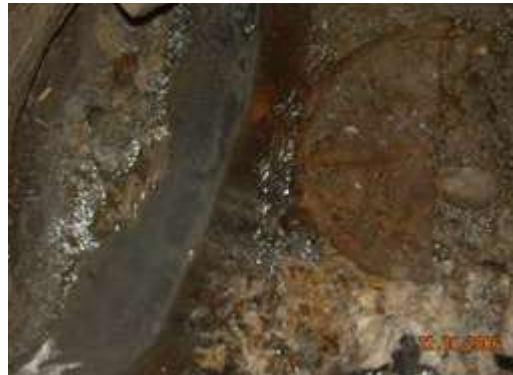
Top View

Bench and Channel debris.

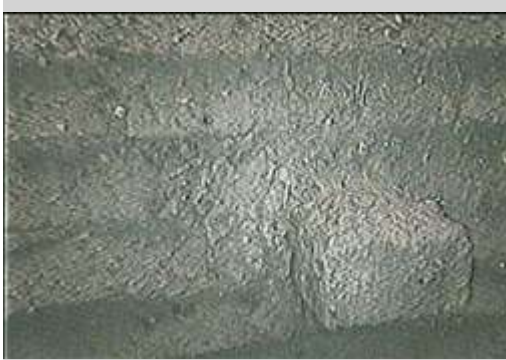
Brick step

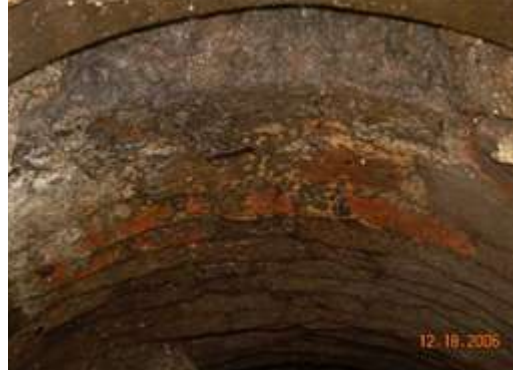
Defect

☒ **Leaks**

☒ **Deteriorated**

☒ **Joint**

☒ **Wall**

☒ **Mortar**

Frame leaks. Adjustment deterioration and infiltration. Corbel infiltration.

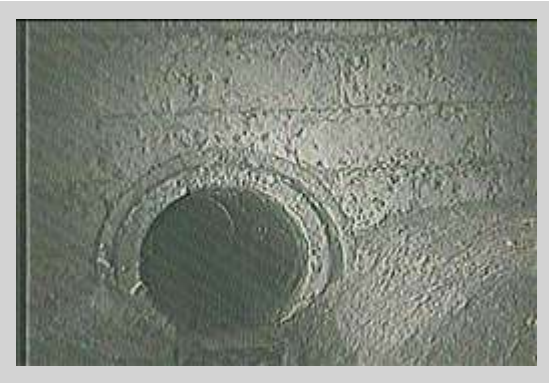
### 6 in. Circular Gravity Sewer Pipe Out @ 12 O'Clock

Invert Depth: **5.98** (ft.) Flow Characteristics: **Slow**

Infiltration: **None** Pipe Seal Cond: **Unknown**

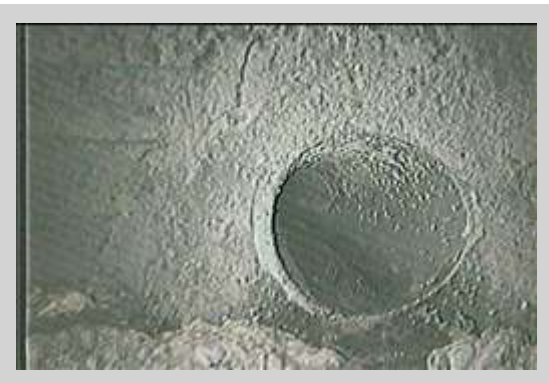
### 6 in. Circular Gravity Sewer Pipe In @ 4 O'Clock

Invert Depth: **5.32** (ft.) Flow Characteristics: **None**

Infiltration: **None** Pipe Seal Cond: **Unknown**

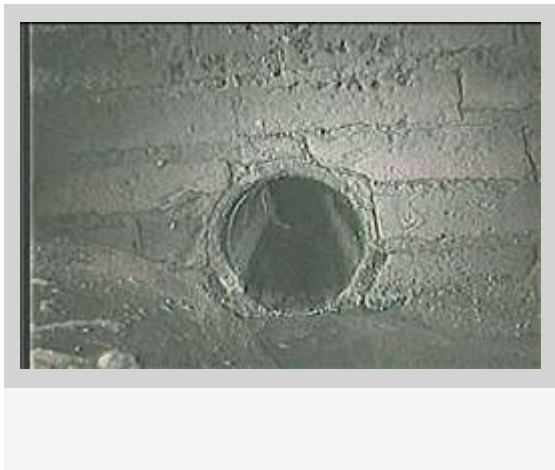
Pipe In @ 7 O'Clock

Infiltration: **Evidence** Pipe Seal Cond: **Cracked**
